Monitoring DATA collected by: M. Green and J. Young Date: 9/12/11

UT to Dixon Branch

Site 19

Year 3 Summer – September 2011

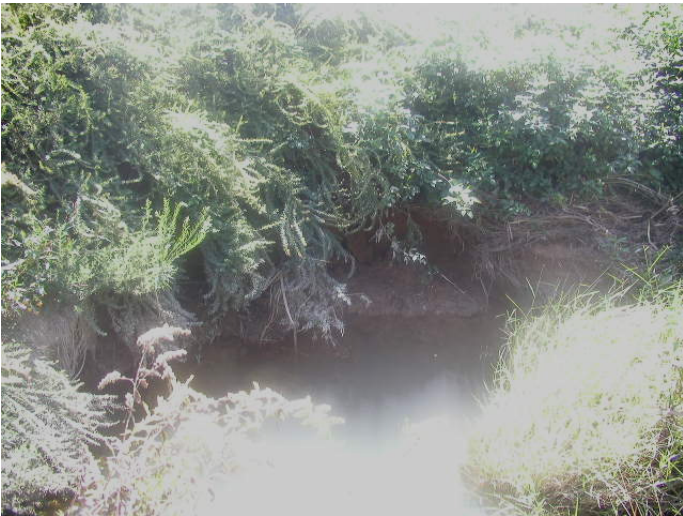
UT to Dixon Branch (Site 19) stream relocation is stable for the Year 3 Summer evaluation, except for, some areas of bank scouring that were noted previously upstream of the pipe crossing at Sta. 10+80 Y-7 and Sta. 10+40 Y-7. NCDOT has installed live stakes along the streambank to help stabilize these areas of scouring behind these J-hooks. The areas of bank scouring show little or no changes since the last evaluation. The area downstream of the pipe that had extensive erosion was repaired during May 2010. Evidence of a bankfull event has been noted since last monitoring evaluation. NCDOT will continue to monitor channel stability at this stream relocation.

Date 9/12/11	Station 10+80 Y-7 (additional photo)	Station 10+40 Y-7 (additional photo)	Station	Station Number	Station Number
Structure Type					
Is water piping through or around structure?					
Head cut or down cut present?					
Bank or scour erosion present?	Bank scouring on left bank behind J-hook	Bank scouring on left bank behind J-hook			
Other problems noted?

Left bank scouring at end of J-Hook @ Sta. 10+80 Y-7

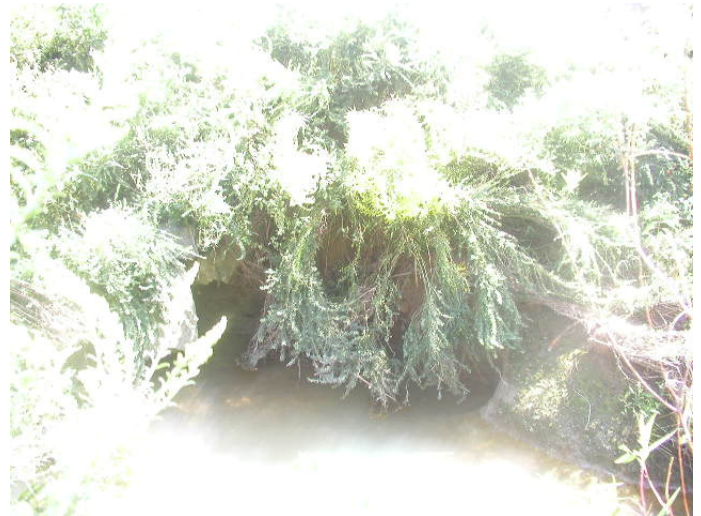
Left bank scouring at end of J-Hook @ Sta. 10+40 Y-7
